Determination of Geometric and Signaling Hazards on Interurban Roads: Critical Perspective for Optimizing Safety on Route 2502

Route 2502, between PR 5+000 and PR 28+000, is a high-traffic road corridor on the Pan-American Highway, with a high risk of accidents due to the interaction of different road actors. This study identifies critical accident areas, analysing geometric and signalling factors to propose corrective measures to improve road safety. Through the analysis of statistical data, signage inventories and road safety audits, the main risk points and their causes were determined. The results show the need for interventions in signage, road geometry and speed control to reduce the vulnerability of drivers and pedestrians. This work provides key tools for the planning of mitigation strategies in road infrastructure.

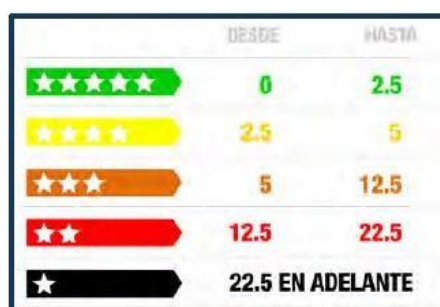
Image 1. IRAP score

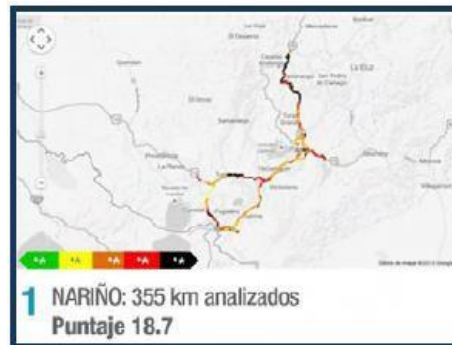
Image 2. IRAT department of Nariño
Source: Road Prevention Fund Corporation
In original language Spanish

According to the Road Prevention Fund, the department of Nariño obtained one of the worst scores in road safety, with an index of 18.7 points on a scale where a lower value indicates greater safety. This result reflects significant deficiencies in the design, maintenance and signaling of the roads in this region.
